# Manhole Inspection Summary

Manhole # S21I\_\_042MH

**Location** Address: **1911 BOOTH ST**

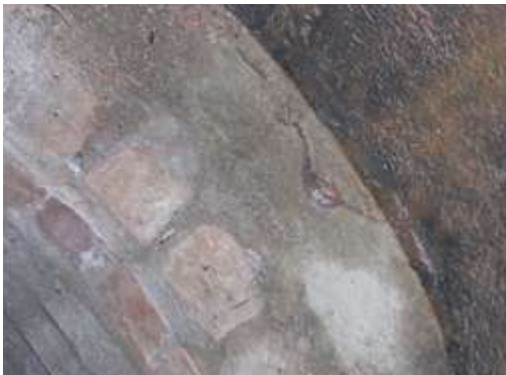
Defect 2

BENCH DEBRIS

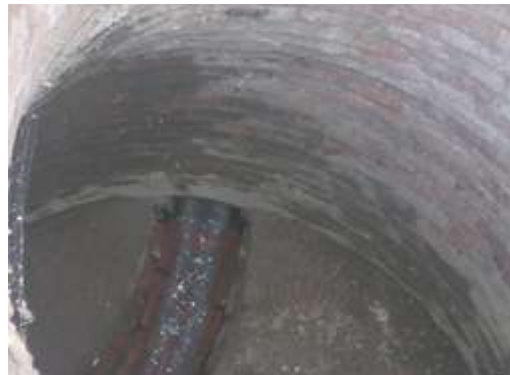
Defect 1

**Chimney / Frame Adjustment** ☒ Exists Material: **Brick and Concrete** ☐ Parged Height: **6** (in.)  
Condition: ☐ Sound ☒ **Cracked** ☐ Root Intrusion ☐ Loose Brick ☐ Deteriorated  
Infiltration: ☒ None ☐ Joint ☐ Cracks ☐ Mortar ☐ Roots ☐ Wall

CRACKED CHIMNEY

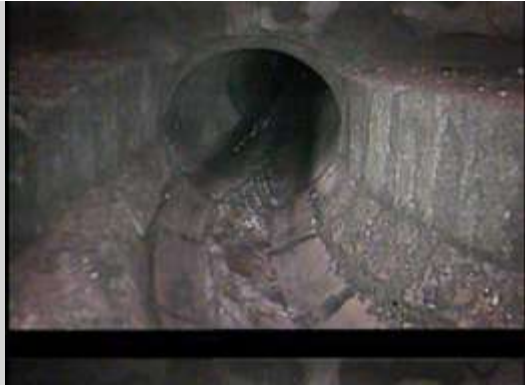
12 O'Clock Outflow

8 in. Circular Gravity Sewer  
Pipe Out @ 12 O'Clock

Pipe Height: **8.4** (in.) Rod and Bar (Angled)  
Pipe Material: **Clay** ☐ Pipe Lined  
Invert Depth: **8.91** (ft.) Flow Characteristics: **Slow**  
Deposits: ☒ None ☐ Mud ☐ Sludge ☐ Debris ☐ Grease  
Silt Depth: (in.) Deposits Extent:  
Infiltration: **None** Pipe Seal Cond: **Sound**

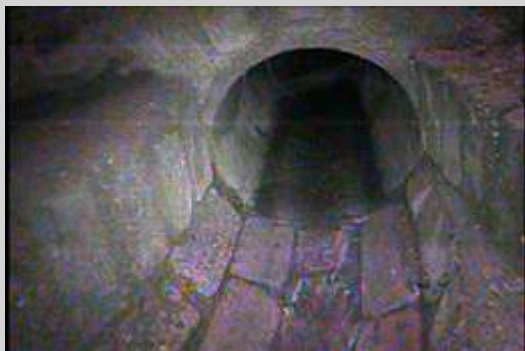
3 O'Clock Inflow

8 in. Circular Gravity Sewer  
Pipe In @ 3 O'Clock

Pipe Height: **8.4** (in.) Rod and Bar (Angled)  
Pipe Material: **Clay** ☐ Pipe Lined  
Invert Depth: **8.71** (ft.) Flow Characteristics: **Slow**  
Deposits: ☒ None ☐ Mud ☐ Sludge ☐ Debris ☐ Grease  
Silt Depth: (in.) Deposits Extent:  
Infiltration: **None** Pipe Seal Cond: **Sound**
